Water Leakages Through Banks of Hammam-Grouz Dam (Algeria)

This study highlights the problems of these escapes at the level of the Hammam Grouz dam and quantified the volume lost especially through right bank of the work.

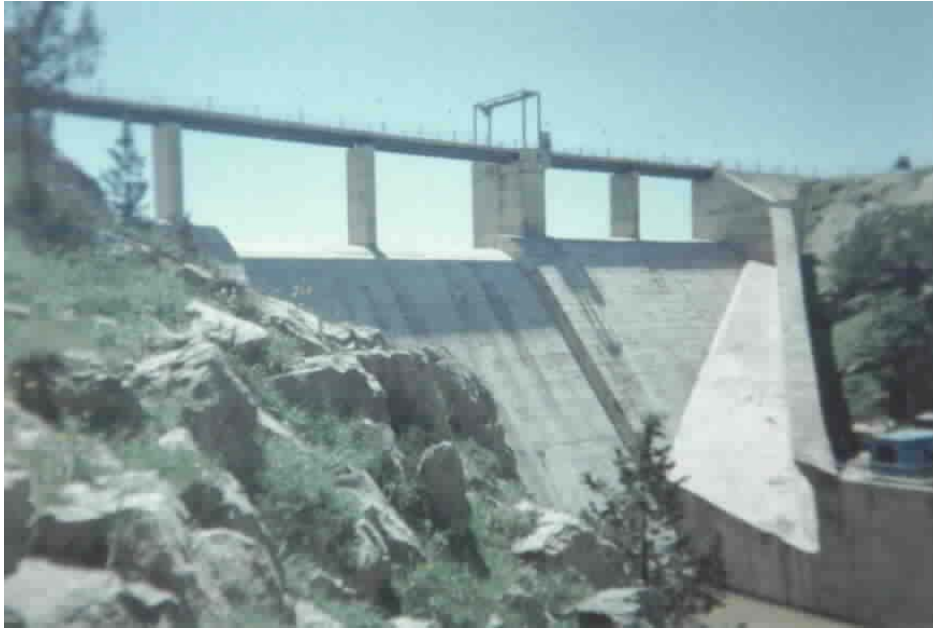
Photograph 1: General sight of the dam of the Hammam-Grouz

Of an initial capacity of 45 million m³ and a height of 49,5 m, the Hammam Grouz dam was carried out during the period going of 1981 with 1987 on wadi Rumel. It is a dyke of the Gréager type: a concrete dam and shotcrete on the level of two banks. An argillaceous carpet on the level of the basin was produced over a length of 180m. The minimum level of the dam is at the coast 691,00 NGA, whereas that of the clay carpet is at the coast 705,00NGA. The work has two crest gates of rising; the first carried out in the middle of the dam represents the principal crest gate. Its coast is to 727,00 NGA. The second crest gate is subdivided into two and have same dimensions one, on the level of right bank and the other, on the level of left bank, and they are at the coast 728,50NGA (NAD, 2003).

On the other hand, the coast of high waters is with 736,50 NGA. Photograph 1 illustrates the site and the type of the dam carried out.

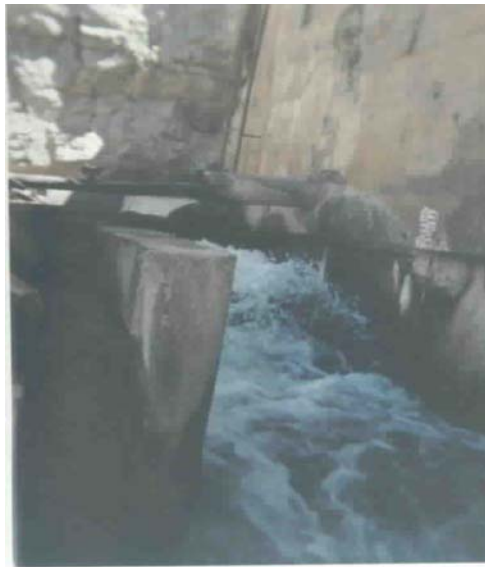
Photograph 2: Drainage which flees in the lower gallery

The Hammam Grouz dam encounters difficulties of storage of water coming from the Rhumel wadi, since the medium flow of water leakages through right bank borders 50000 cubic meters per day (ANB, 2003). Photographs 2, and 3 show successively water which leaves the lower gallery (where the drains function like water jets) and by resurgences which we numbered from 1 to 3.

This height of water of lake A creates an almost constant and permanent hydrostatic compressive force on the supports of the dam during this period. This caused the 20/04/2003 of the considerable water losses through right bank. The geology of the site primarily made up of the cretaceous limestone stuffed by argillaceous materials and the absence of work of consolidation on the level of right bank are the principal causes of this considerable water leakage. The underground flow creates by the hydrostatic pressure contributed to the drive of materials of filling by increasing the cross-sections of stream discharge.

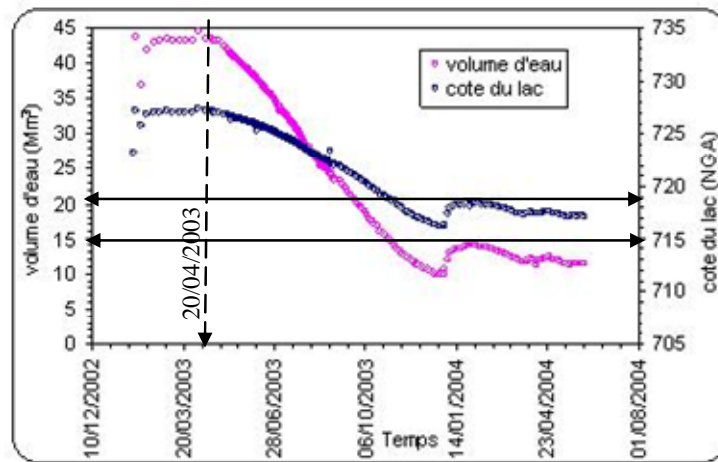
Figure 3: Variation of the couple dimensions and volume of water in the lake according to time dam Hammamm-Grouz-Milla-Agérie (Given ANB)

To put forward the relation which exists between the water dimension of the lake and the volume lost by the escapes since the appearance of the phenomenon, we represent on figure 3, the variation of the couple, the dimension and the volume of water according to time.

It is interesting to note that the two curves of the volume of water and the dimension of the lake are cut exactly at the date of the apparition of the water leakages of right bank (April 20, 2003). The graph also specifies that the water leakages through right bank of the Hammam-Grouz dam sufficiently took time to appear on April 20, 2003 in the form of a water jet of flow definitely higher than the normal.

The increase in time in volume in leakage water testifies to the enlarging to the corridors to circulations through right bank. The reddish color represents in fact, that a quantity of dissolved clay in water. We note that the dimension of the lake is always lower than 719NGA, i.e. volume does not exceed the 15 million m^3 , which wants to say that approximately 30 million m^3 of water of the total volume of the dam were lost following the leakages through right bank.

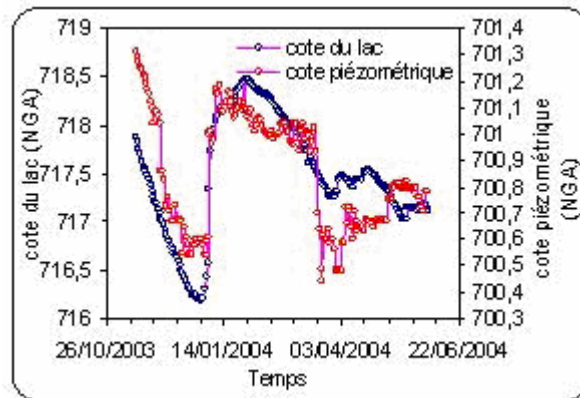
Figure 4: Piezometer S6-Variations in the time of dimensions of the lake and piezometer (Given ANB)

Piezometry has a great utility for the determination of the defective zones on the level of banks and the foundation of the dam. The variation of the piezometric dimension and the dimension of the lake in the course of time make it possible to deduce the anomalies which occur on the level of the zone crossed by the piezometer. On figures 4 and 5, we represent the variation of the couple dimension lake and dimension piezometric according to time for the piezometers S6 and P56 locating in right bank.

We note that for the same dimension of the lake each piezometer indicates two values this confirms the existence of the anomalies on the level of the zones crossed by these piezometers. The last recorded values are lower than the first, this confirms that there is a deterioration of the zones crossed by these piezometers and consequently the water leakages increase in time.
